Stability assessment of Maligcong rice terraces: Linking soil properties and geometry to factor of safety

College of Engineering and Information Technology, Kalinga State University, Bulanao, Tabuk City 3800, Philippines

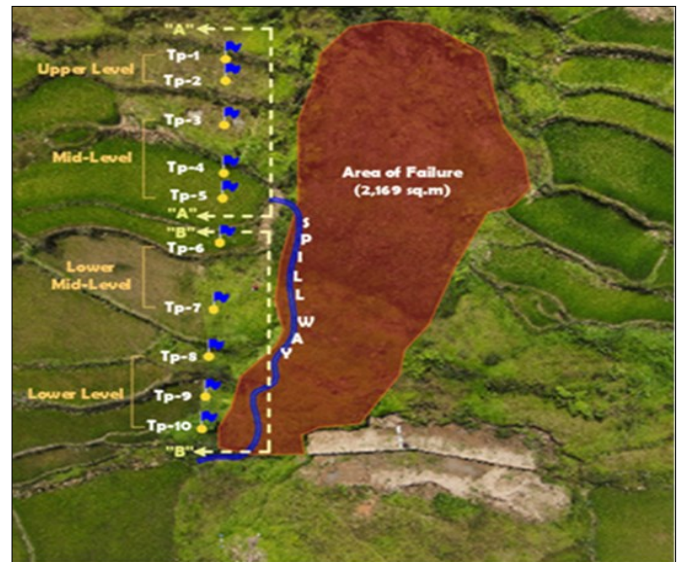
Fig. 2. Specific location of test points.

A total of 36 soil specimens were collected from 10 test points located on the rice terraces adjacent to the failed section (Fig. 2). Samples were taken at 1 m intervals from the ground surface to a depth of 4 m at each test point. Soil samples were extracted using a 6-inch diameter soil sampler and were subsequently subjected to soil classification USCS, according to ASTM D2487. Unit weight determination was conducted under moist conditions following ASTM D2487 guidelines.

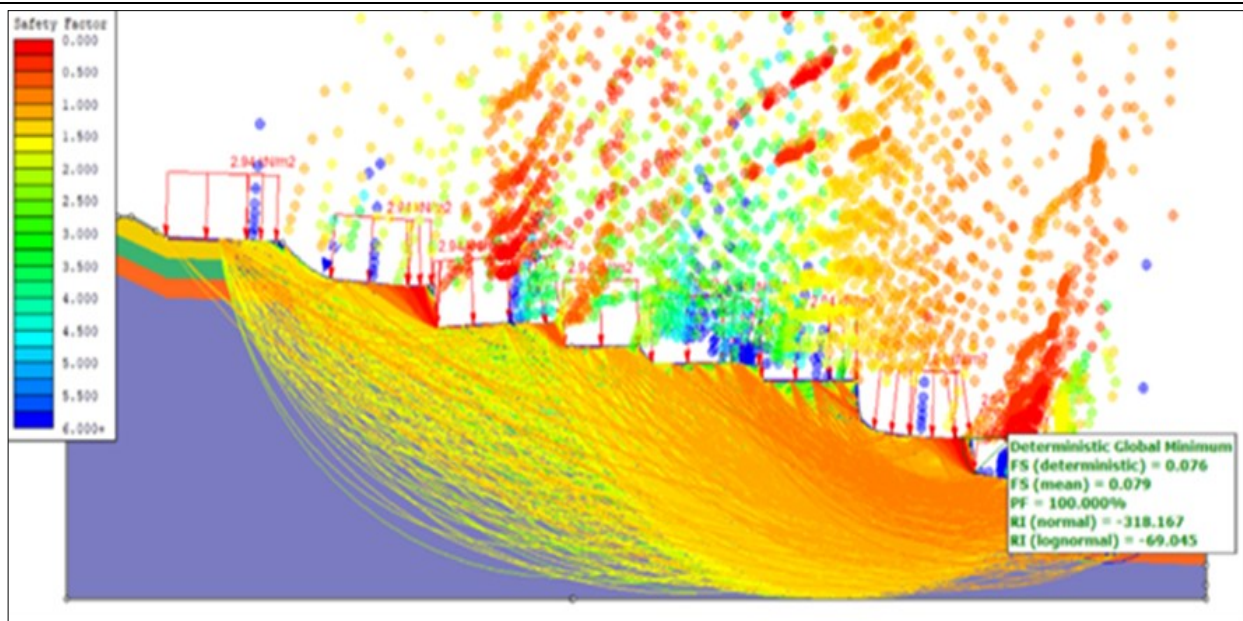
Fig. 9. Critical failure slips implied on taller paddies.

The individual slope stability analysis of the eight rice paddies, showing that taller paddies with heights ranging from 1.4 to 2.6 m consistently exhibited instability (FoS<1) based on the Janbu method of global FoS calculation (Table 7). When analyzed using the Bishop's method, instability was observed in paddies with heights between 1.9 and 2.6 m. This suggests that the height of the rice paddies is a critical factor in determining their slope stability (Fig. 9). Taller paddies are more prone to instability and a lower FoS, as the increased height can lead to higher shear stresses and a greater potential for slope failure (83, 84).
